INDOOR AIR QUALITY ASSESSMENT

**Lawrence Juvenile Court
10 Railroad Street
Lawrence, Massachusetts**

Prepared by:
Massachusetts Department of Public Health
Bureau of Environmental Health Assessment
November, 2001

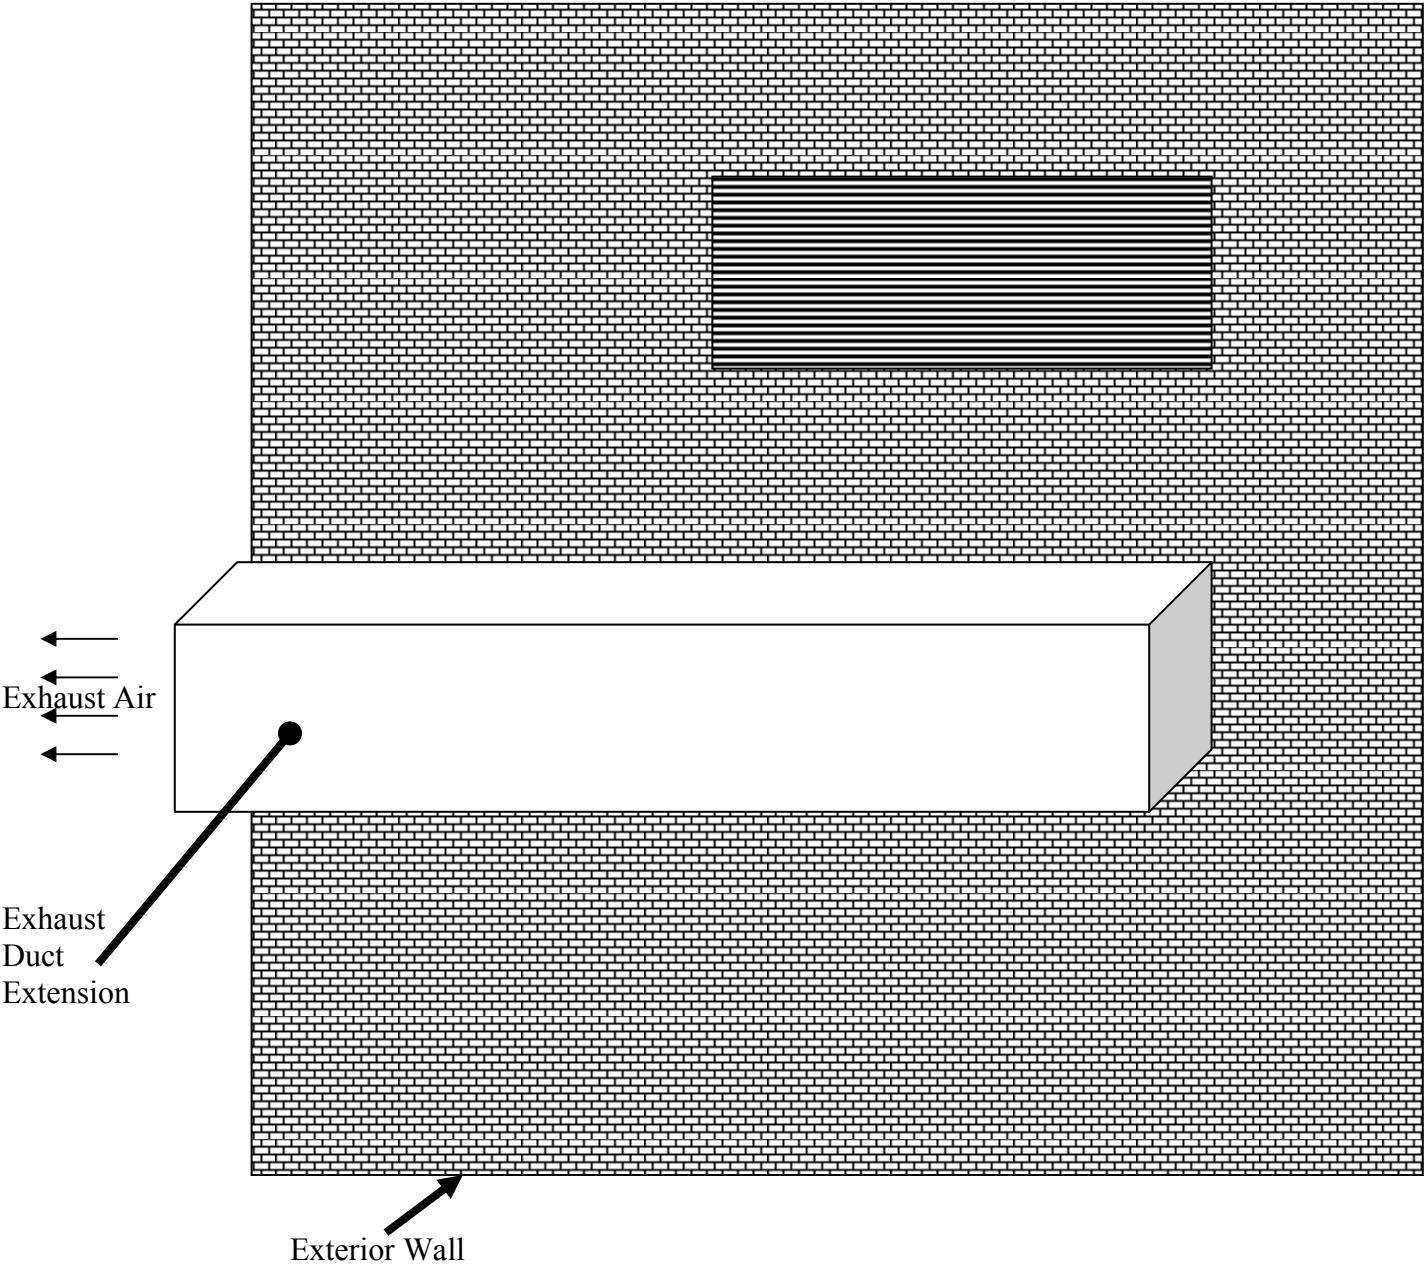
Figure 1

Possible Reconfiguration of Exhaust Vent

5. The feasibility of retrofitting a combination hood/duct to the exterior of the building to direct exhaust air away from fresh air intakes should be examined (see Figure 1).

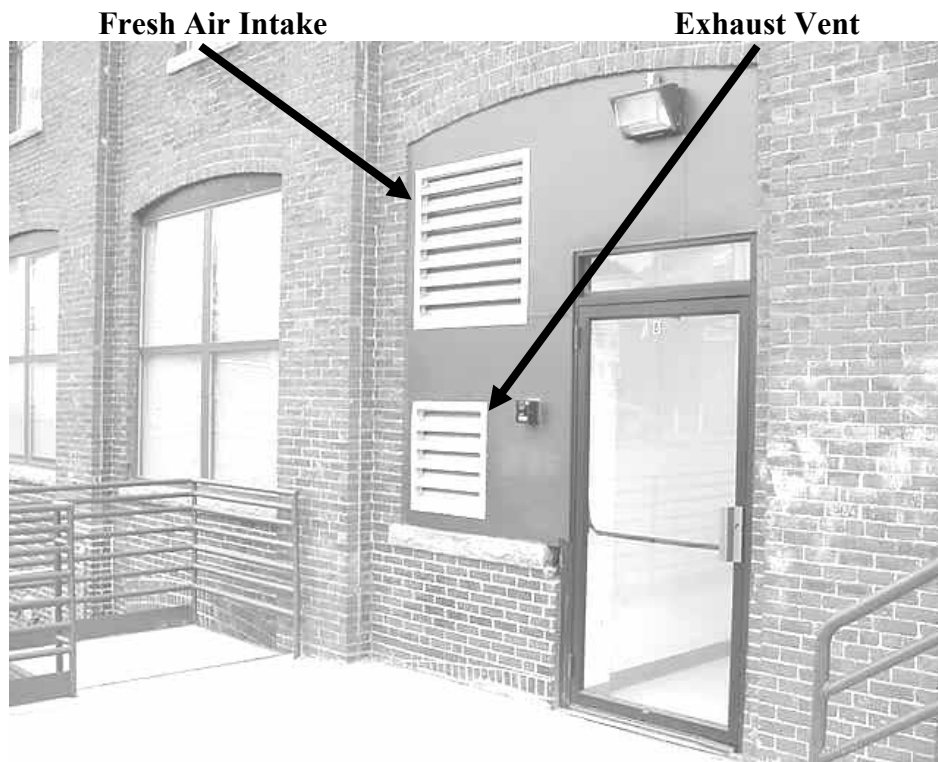
Picture 1

Exhaust ventilation on each floor is provided by ducted, return air vents that are connected to each air-handling unit. Exhaust vents are also located on the exterior wall of the mechanical rooms on each floor of the LJC. Of note is the location of the fresh air intake to the exhaust vent. The larger vent appears to be the fresh air intake (see Picture 1). The smaller vent was found to be ejecting air from the building. In this configuration, it is likely that the fresh air intake is capturing air from the exhaust vent

(called short-circuiting), resulting in the recirculation of building pollutants, including waste heat, water vapor and carbon dioxide. In addition, odors from one section of a floor can be distributed to other areas of the floor serviced by the AHU.

Fresh Air Intake and Exhaust Vents

4. Consult a ventilation engineer to maximize the operation of the building's HVAC system. Have HVAC firm fully evaluate existing ductwork system for function to ensure proper distribution of fresh outside air to occupied areas.

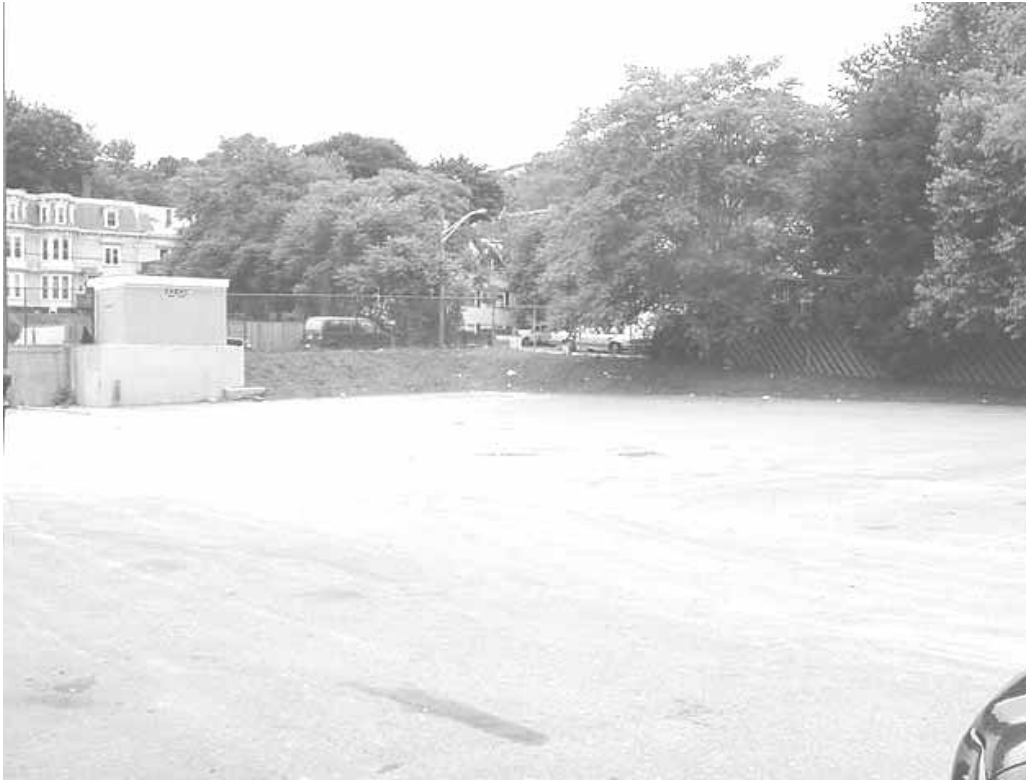
Picture 2

Remediation recommendations concerning flooding in the basement offices were previously made in a letter to the Honorable Barbara Dortch-Okara (MDPH, 2001, Appendix A). Building management staff indicated that accumulated rainwater from Current Hill Road rolled down an embankment (see Pictures 2 and 3) at a rate that overwhelmed the existing parking lot drain. As water filled the parking lot, water ran down the garage ramp (see Picture 4) and penetrated into the cellblock, cellblock control center and front lobby.

Flood Water Entered Parking Lot down This Embankment

1. Implement corrective actions recommended in letter concerning flooding as soon as possible (see Appendix A).
2. Measures should be taken to direct water away from the parking lot. Examine the feasibility of creating a levee at the top of the parking lot embankment to prevent flooding of the parking lot. Another consideration would be to create a slope to raise the level of the top of the garage driveway.

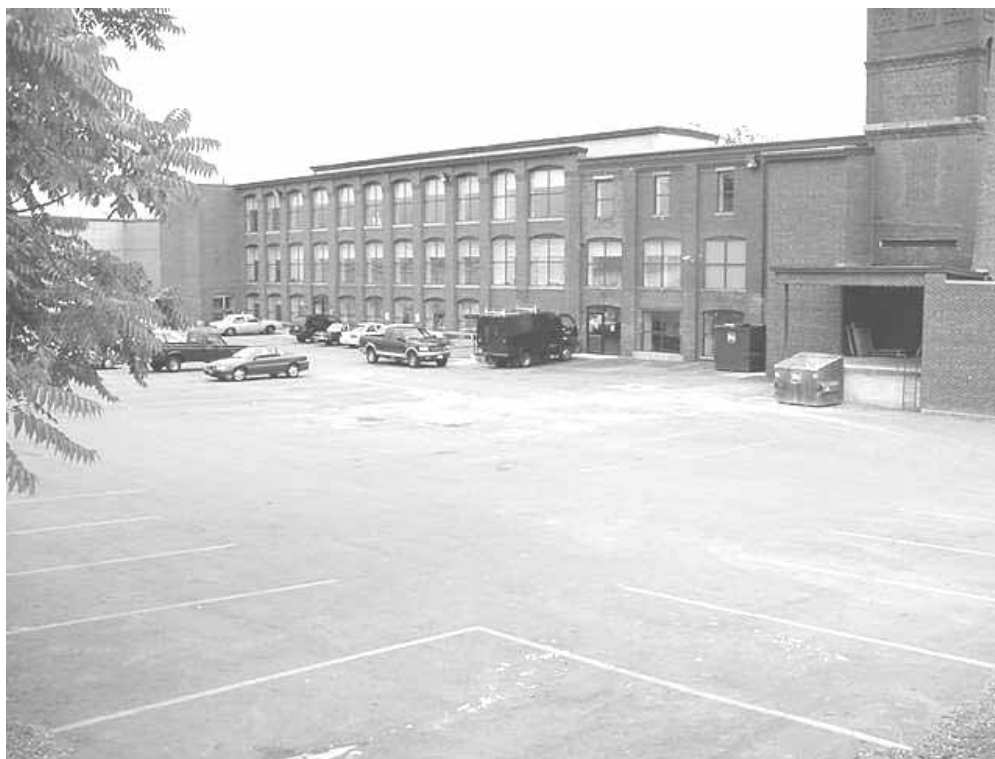
Picture 3

Parking Lot From the Top of the Embankment

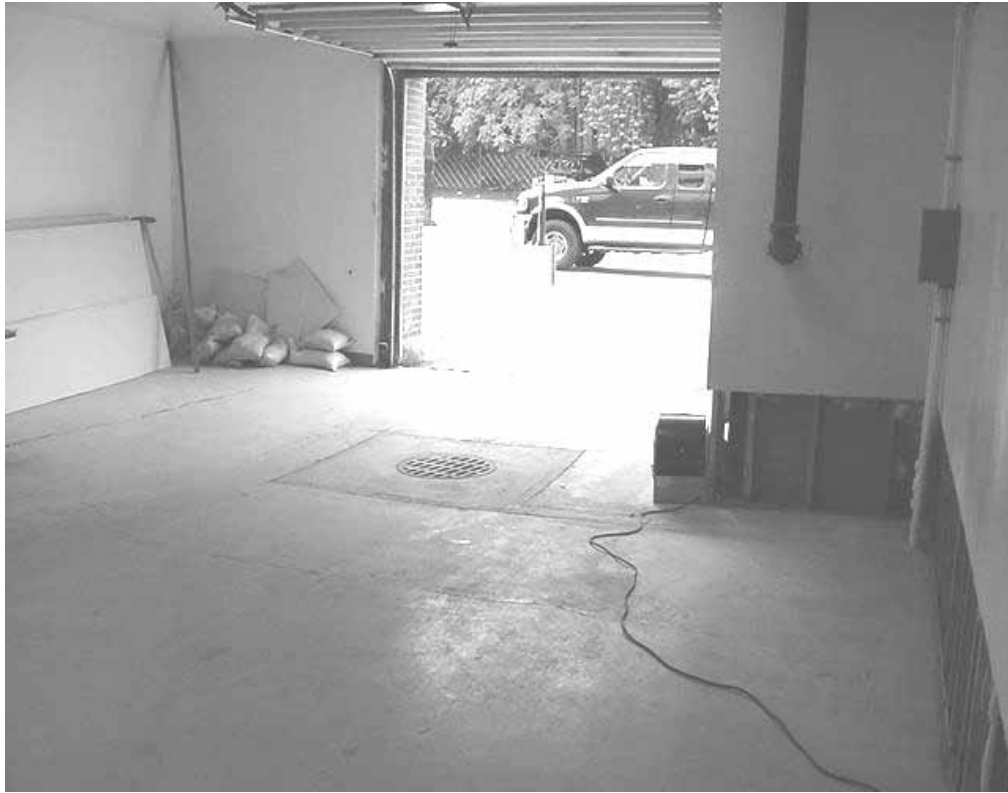
Picture 4

Garage Ramp Sloping down from Parking Lot

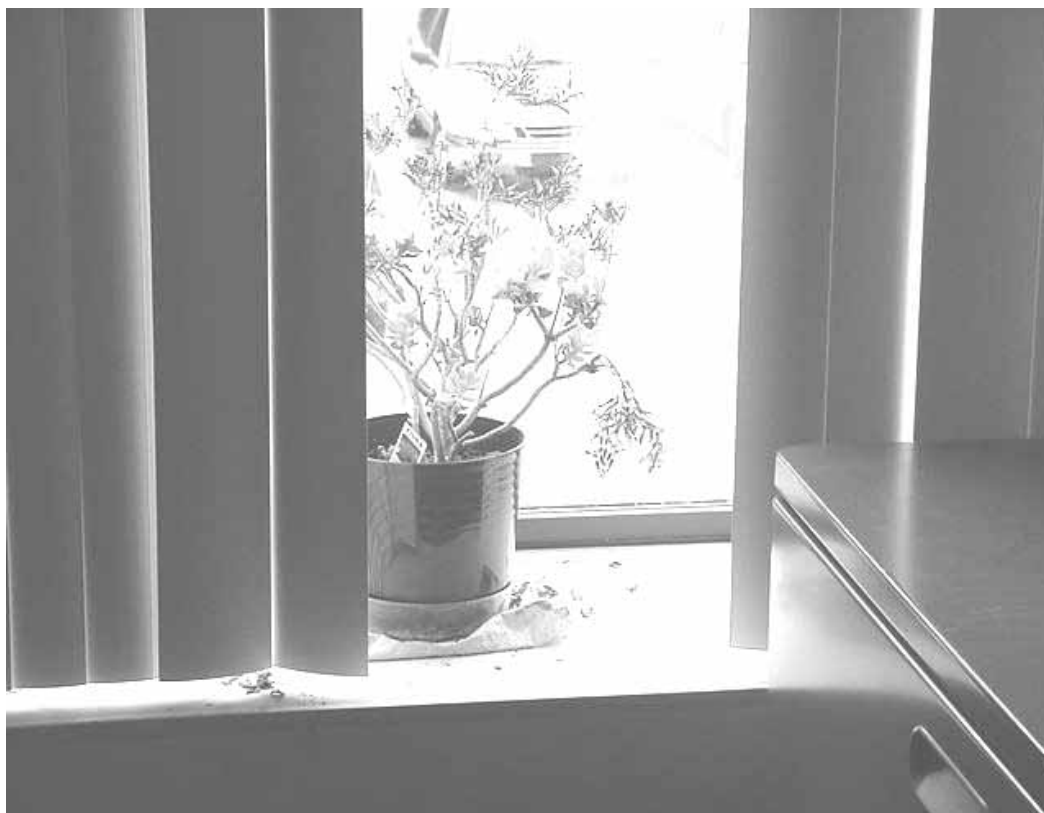
Picture 5

Plants were noted on windowsills resting on paper towels (see Picture 5). Moistened plant soil, drip pans and standing water can serve as a source of mold growth. Moistened paper can also be a mold growth medium. Plants should be equipped with drip pans and over watering should be avoided.

Plants Noted on Paper Towels on Windowsills

8. Ensure all plants are equipped with drip pans. Examine drip pans periodically for mold growth and disinfect with an appropriate antimicrobial where necessary.

Consider reducing the number of plants.

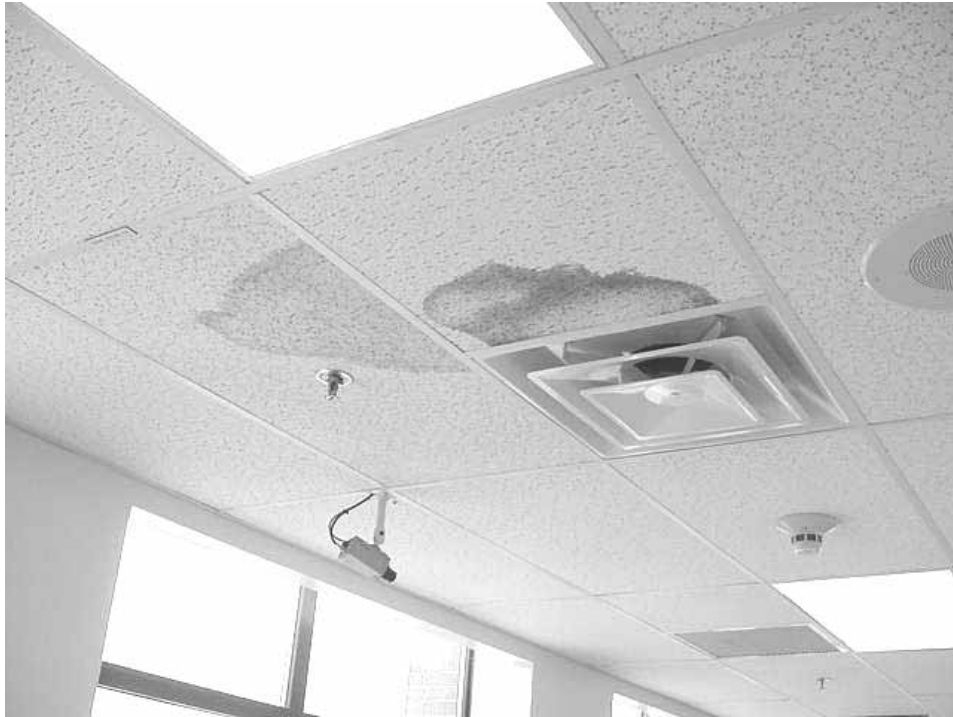
Picture 6

A number of water damaged ceiling tiles were noted on the second floor (see Picture 6). Water-damaged ceiling tiles can provide a medium for microbial growth especially if wetted repeatedly. These materials should be replaced after a water leak is discovered.

Water Damaged Ceiling Tiles in Second Floor Lobby

7. Replace water damaged ceiling tiles. This measure will remove actively growing mold colonies that may be present. Ceiling tiles should be removed at a time when employees are not present in the workplace. Contain the area where ceiling tiles are removed to prevent the spread of dust and mold spores in the workplace. This practice should be conducted routinely.

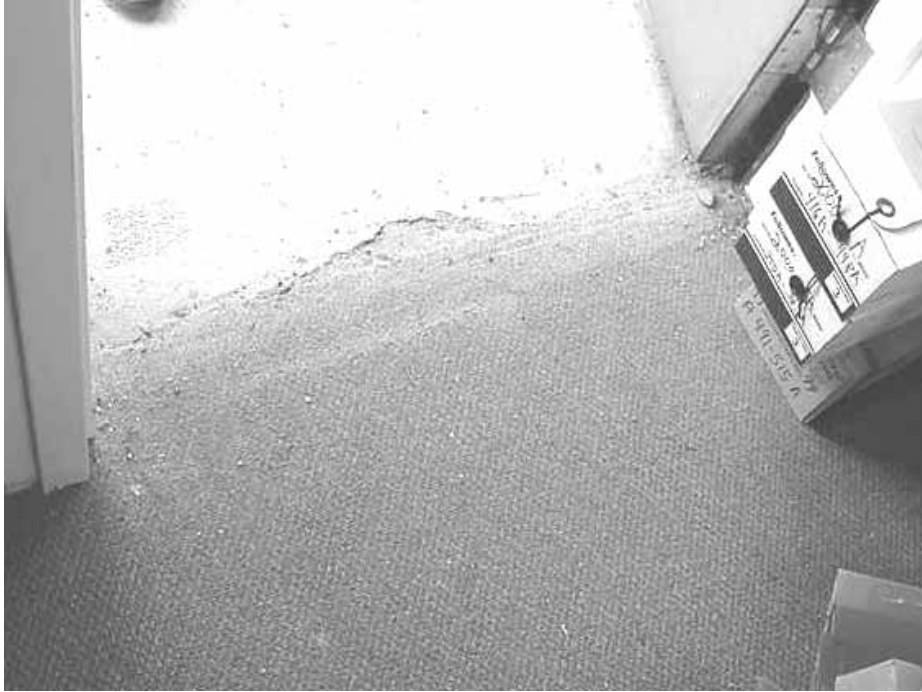
Picture 7

Wall-to-wall carpeting adjacent to exterior door thresholds near the south exterior wall of the building appeared to be water damaged (see Picture 7). In addition, water coolers located on wall-to-wall carpeting were noted in offices (see Picture 8). Use of the water cooler can result in chronic moistening of carpeting. Water damaged carpeting can serve as mold growth media. The American Conference of Governmental Industrial Hygienists (ACGIH) recommends that porous materials be dried with fans and heating within 24 hours of becoming wet (ACGIH, 1989). If porous materials are not dried

within this time frame, mold growth may occur. Water-damaged porous materials cannot be adequately cleaned to remove mold growth. The application of a mildewcide to moldy materials is not recommended.

**Water Damaged Carpeting Adjacent to Exterior Door Thresholds
near the South Exterior Wall of the Building**

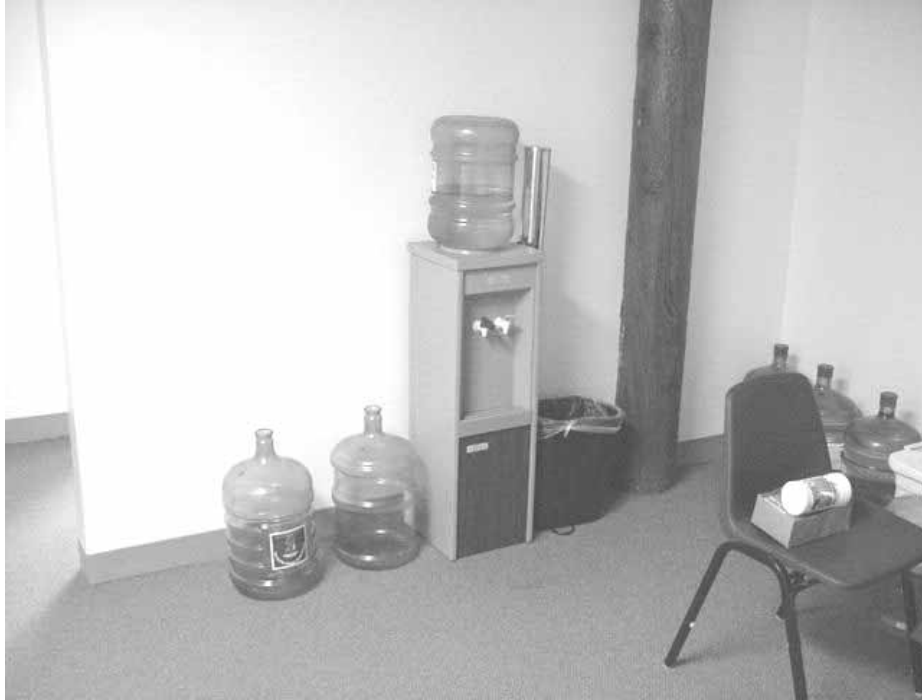
Picture 8

Water Coolers Located on Wall-To-Wall Carpeting
